# Annual Inspection Report

**Long Furlong Play Area**

<b>Client:</b>	Over Parish Council
<b>Address:</b>	Over Community Centre 16 The Doles Over Cambridgeshire CB24 5NW
<b>Date:</b>	29th April 2026
<b>Inspector:</b>	Peter Briggs

**Assessed site risk at time of inspection**  
**Medium Risk (12)**

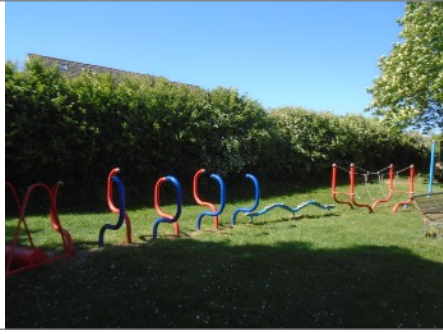
<b>Item</b>	Agility Trail				
<b>Supplier</b>	Wicksteed				
<b>Surface</b>	Grass				
<b>Risk Rating Overall</b>	Very Low	Low	Medium	High	Unacceptable
		7

Chain/connecting link(s) wear evident. <b>Recommendation:</b> Monitor to replace at 40% dia wear.	7
---	---	---

Loose fixing(s) evident. <b>Recommendation:</b> Consider to retighten loose fixing(s) as required.	7
---	--	---

Metal core exposed on rope. <b>Recommendation:</b> Monitor to repair this condition.	6
---	--	---

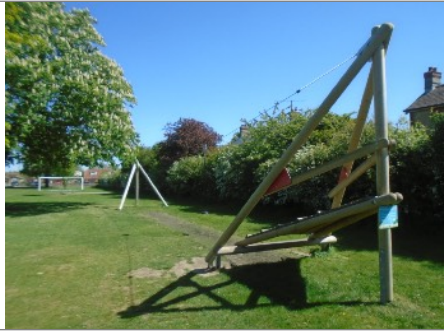
<b>Item</b>	Zipline				
<b>Supplier</b>	EIBE				
<b>Surface</b>	Grass Matting				
<b>Risk Rating Overall</b>	Very Low	Low	Medium	High	Unacceptable
			8

Button seat too close to support posts at stop end. <b>Recommendation:</b> Adjust the stop to at least 2m from support at a 45 degree angle.	8
---	--	---

Review recommended inspection and maintenance schedules as detailed from the supplier/manufacturer for zip line unit.	8
--	---	---

Slack cable evident. <b>Recommendation:</b> Retighten cable as necessary.	6
---	---	---

Damaged rubber sleeve evident. <b>Recommendation:</b> Monitor to repair this condition.	6
---	---	---

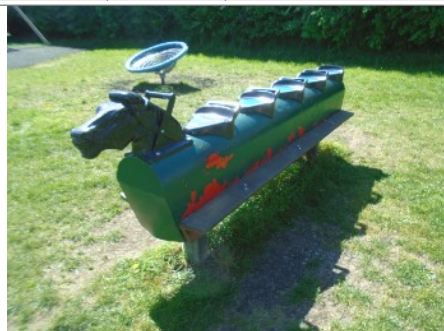
<b>Item</b>	Horse Rocker				
<b>Supplier</b>	Wicksteed				
<b>Surface</b>	Grass Matting				
<b>Risk Rating Overall</b>	Very Low	Low	Medium	High	Unacceptable
		7

No faults found during the inspection. <b>Recommendation:</b> No action required, monitor this item.	7
---	--	---

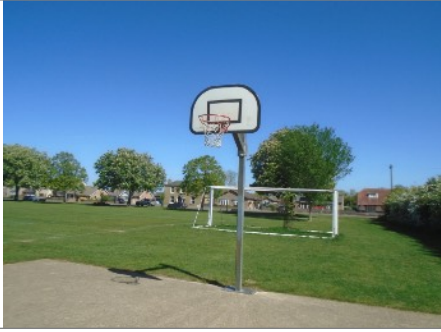
<b>Item</b>	Basketball Post				
<b>Supplier</b>	Fenland Leisure				
<b>Surface</b>	Concrete				
<b>Risk Rating Overall</b>	Very Low	Low	Medium	High	Unacceptable
		6

EN signage missing.  
**Recommendation:**  
 Consider "Do not climb framework or hang from the ring" signage.

Trip point(s) evident.  
**Recommendation:**  
 Build up area to remove trip hazard.

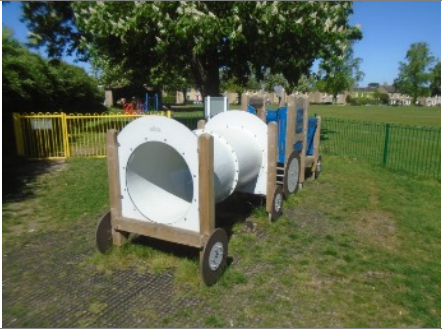
<b>Item</b>	Play Tractor				
<b>Supplier</b>	EIBE				
<b>Surface</b>	Grass Matting				
<b>Risk Rating Overall</b>	Very Low	Low	Medium	High	Unacceptable
		4

No faults found during the inspection.  
**Recommendation:**  
 No action required, monitor this item.

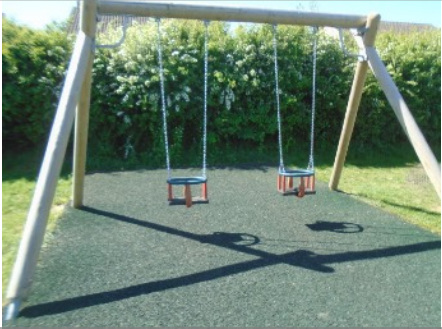
<b>Item</b>	1 Bay 2 Cradle Swing				
<b>Supplier</b>	EIBE				
<b>Surface</b>	Ruber Bonded Fibre				
<b>Risk Rating Overall</b>	Very Low	Low	Medium	High	Unacceptable
		5

No faults found during the inspection.  
**Recommendation:**  
 No action required, monitor this item.

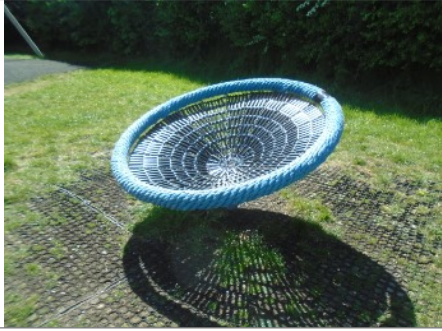
<b>Item</b>	Spinning Basket				
<b>Supplier</b>	Unknown				
<b>Surface</b>	Grass Matting				
<b>Risk Rating Overall</b>	Very Low	Low	Medium	High	Unacceptable
		5

No faults found during the inspection. <b>Recommendation:</b> No action required, monitor this item.	5
	<b>Recommendation:</b>	
	<b>Recommendation:</b>	
	<b>Recommendation:</b>

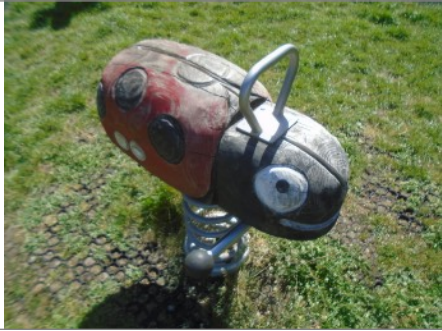
<b>Item</b>	Ladybird Rocker				
<b>Supplier</b>	EIBE				
<b>Surface</b>	Grass Matting				
<b>Risk Rating Overall</b>	Very Low	Low	Medium	High	Unacceptable
		7

Crack/splits evident in body. <b>Recommendation:</b> Monitor to keep free from sharp edges.	5
 	As above finding. <b>Recommendation:</b> As above comment.	5
 	Missing end cap(s). <b>Recommendation:</b> Replace as required.	7
	<b>Recommendation:</b>

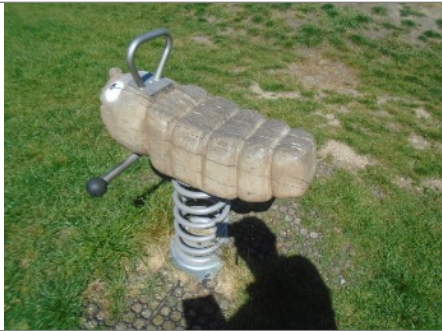
<b>Item</b>	Bug Rocker				
<b>Supplier</b>	EIBE				
<b>Surface</b>	Grass Matting				
<b>Risk Rating Overall</b>	Very Low	Low	Medium	High	Unacceptable
		5

Crack/splits evident in body. <b>Recommendation:</b> Monitor to keep free from sharp edges.	5
	<b>Recommendation:</b>	
	<b>Recommendation:</b>	
	<b>Recommendation:</b>

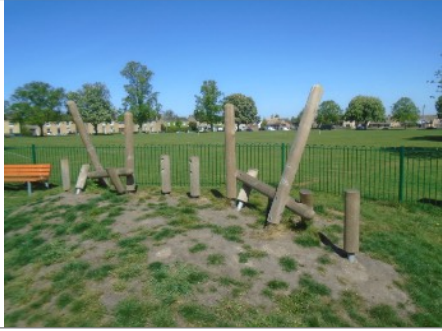
<b>Item</b>	Log Agility Trail				
<b>Supplier</b>	EIBE				
<b>Surface</b>	Grass				
<b>Risk Rating Overall</b>	Very Low	Low	Medium	High	Unacceptable
		6

Crack/splits evident in various posts <b>Recommendation:</b> Monitor to keep free from sharp edges.	6
	<b>Recommendation:</b>	
	<b>Recommendation:</b>	
	<b>Recommendation:</b>

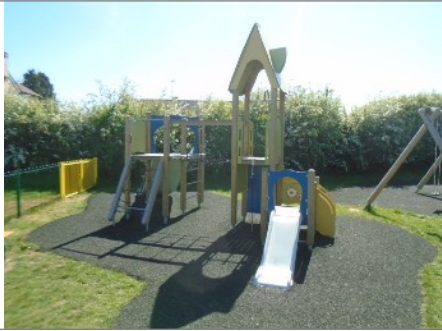
<b>Item</b>	Multiplay Unit				
<b>Supplier</b>	EIBE				
<b>Surface</b>	Rubber Bonded Fibre				
<b>Risk Rating Overall</b>	Very Low	Low	Medium	High	Unacceptable
		7

No faults found during the inspection. <b>Recommendation:</b> No action required, monitor this item.	7
	<b>Recommendation:</b>	
	<b>Recommendation:</b>	
	<b>Recommendation:</b>

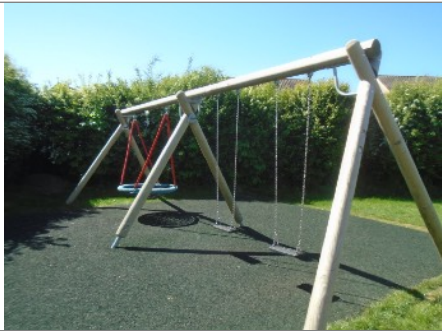
<b>Item</b>	2 Bay 1 Basket 2 Flat Swing				
<b>Supplier</b>	EIBE				
<b>Surface</b>	Rubber Bonded Fibre				
<b>Risk Rating Overall</b>	Very Low	Low	Medium	High	Unacceptable
			12

Safety chain connector not fully engaged. <b>Recommendation:</b> Retighten or replace this fixing and monitor area.	12

As above finding. <b>Recommendation:</b> As above comment.	12

Distorted/loose fixing. <b>Recommendation:</b> Repair as required.	8
	<b>Recommendation:</b>
