## Annual Inspection Report

**The Doles Community Centre Pay Area**

<b>Client:</b>	Over Parish Council
<b>Address:</b>	Over Community Centre 16 The Doles Over Cambridgeshire CB24 5NW
<b>Date:</b>	29th April 2026
<b>Inspector:</b>	Peter Briggs

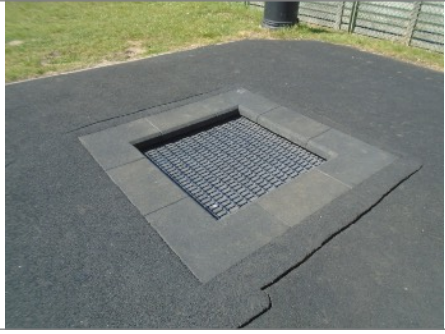
<p>Possible trip point.</p> <p><b>Recommendation:</b> Monitor this condition.</p>	<b>7</b>
---	---	----------

<p>Wet pour edge shrinkage evident.</p> <p><b>Recommendation:</b> Repair asap.</p>	<b>8</b>
---	--	----------

<b>Item</b>	Trampoline				
<b>Supplier</b>	Seilfabrik Ullmann				
<b>Surface</b>	Wet Pour				
<b>Risk Rating Overall</b>	Very Low	Low	Medium	High	Unacceptable
			8

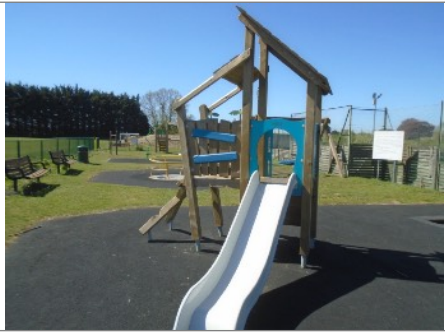
<p>Wet pour edge shrinkage evident.</p> <p><b>Recommendation:</b> Monitor to repair this condition.</p>	<b>8</b>
---	---	----------

<p>Loose fixing(s) evident.</p> <p><b>Recommendation:</b> Retighten loose fixing(s) as required.</p>	<b>7</b>
--	--	----------

<b>Item</b>	Toddler Multiplay Unit				
<b>Supplier</b>	Eibe				
<b>Surface</b>	Wet Pour				
<b>Risk Rating Overall</b>	Very Low	Low	Medium	High	Unacceptable
			8

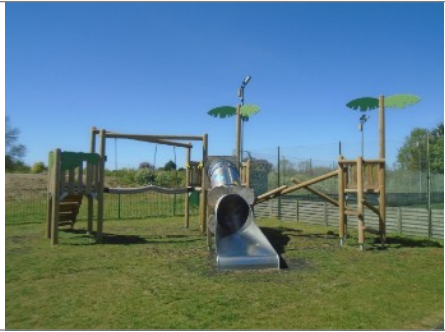
<p>Steep ramp for persons to climb and for user to grip.</p> <p><b>Recommendation:</b> Possible improvement to aid users to climb the ramp recommended. Monitor use to improve if necessary.</p>	<b>8</b>
---	--	----------

<p>Open section between platform using rope walk.</p> <p><b>Recommendation:</b> Monitor use as this can be challenging for some users to walk along.</p>	<b>8</b>
---	--	----------

<p>Wooden blanking panels used in places that appear to be fitted during the installation.</p> <p><b>Recommendation:</b> Comment required from supplier to validate type of material used is correct and is part of the install process.</p>	<b>5</b>
---	--	----------

<p>As above finding.</p> <p><b>Recommendation:</b> As above comment.</p>	<b>5</b>
---	--	----------

<b>Item</b>	Junior/Teenager Multiplay Unit				
<b>Supplier</b>	Unknown				
<b>Surface</b>	Grass Matting				
<b>Risk Rating Overall</b>	Very Low	Low	Medium	High	Unacceptable
			8

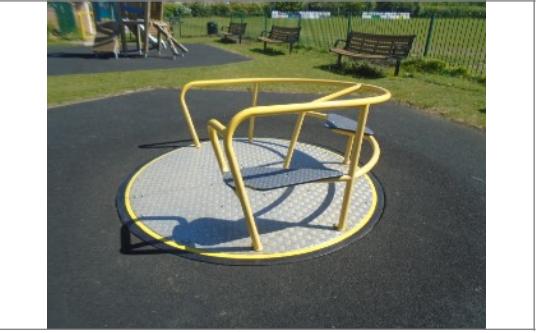
This type of unit is known to possibly move slightly overtime causing possible finger traps. <b>Recommendation:</b> Monitor edge of unit for gaps larger than 8mm and carry out remedial work as required.	8
---	--	---

Wet pour edge shrinkage evident. <b>Recommendation:</b> Repair asap.	8
--	--	---

Slightly worn bearing evident. <b>Recommendation:</b> Monitor to replace bearing.	6
---	---	---

<b>Item</b>	Roundabout				
<b>Supplier</b>	HAGS				
<b>Surface</b>	Wet Pour				
<b>Risk Rating Overall</b>	Very Low	Low	Medium	High	Unacceptable
			8

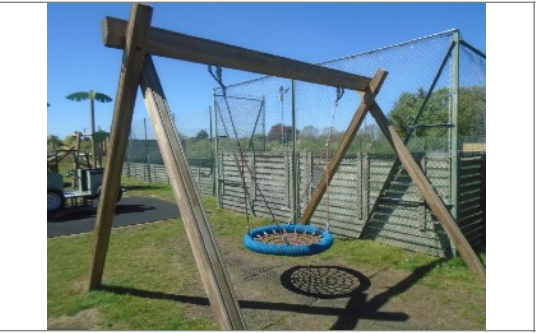
Gaps in matting evident. <b>Recommendation:</b> Replace as necessary.	8
---	---	---

<b>Item</b>	Basket Swing				
<b>Supplier</b>	Fenland Leisure				
<b>Surface</b>	Grass Matting				
<b>Risk Rating Overall</b>	Very Low	Low	Medium	High	Unacceptable
			8

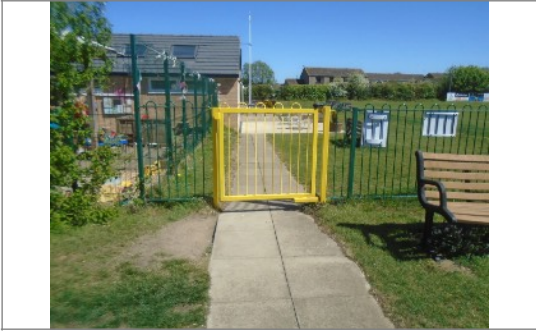
<p>Trip hazard at exit. <b>Recommendation:</b> Improve this condition.</p>	<b>7</b>
---	--	----------

<p>Worn surfacing evident. <b>Recommendation:</b> Reinstate as required.</p>	<b>6</b>
---	--	----------

<b>Item</b>	Gate				
<b>Supplier</b>	Unknown				
<b>Surface</b>	N/a				
<b>Risk Rating Overall</b>	Very Low	Low	Medium	High	Unacceptable
		7

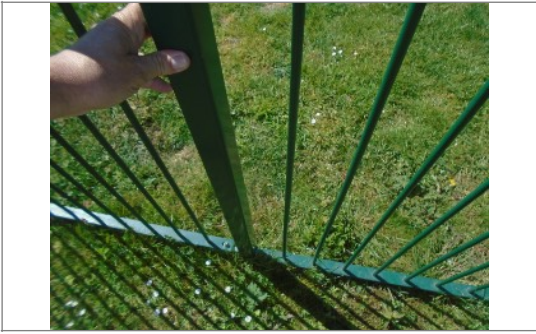
<p>Loose post in ground. <b>Recommendation:</b> Repair this condition.</p>	<b>8</b>
---	--	----------

<p>Damaged wire mesh fencing evident. <b>Recommendation:</b> Repair as necessary.</p>	<b>7</b>
--	---	----------

<b>Item</b>	Fencing				
<b>Supplier</b>	Unknown				
<b>Surface</b>	N/a				
<b>Risk Rating Overall</b>	Very Low	Low	Medium	High	Unacceptable
			8

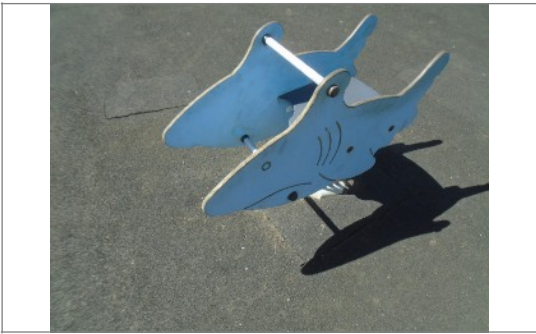
<p>Loose ground fixing(s) evident. <b>Recommendation:</b> Retighten loose fixing(s) as required.</p>	<b>7</b>
---	--	----------

<b>Item</b>	Shark Rocker				
<b>Supplier</b>	HAGS				
<b>Surface</b>	Wet Pour				
<b>Risk Rating Overall</b>	Very Low	Low	Medium	High	Unacceptable
		7

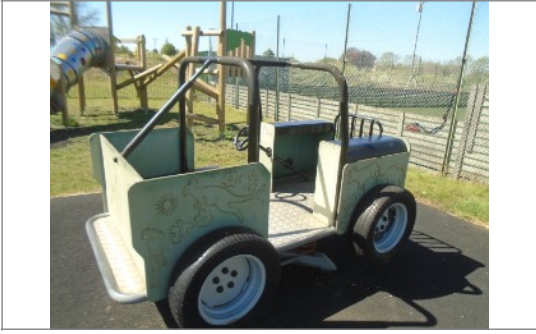
Severe decay to seat area with loose fixings. <b>Recommendation:</b> Repair/replace as required.	12
---	--	----

Missing rubber sleeve evident. <b>Recommendation:</b> Replace missing sleeve.	8
---	---	---

Wet pour edge shrinkage evident. <b>Recommendation:</b> Repair as required.	7
---	---	---

<b>Item</b>	Jeep Rocker				
<b>Supplier</b>	HAGS				
<b>Surface</b>	Wet Pour				
<b>Risk Rating Overall</b>	Very Low	Low	Medium	High	Unacceptable
			12

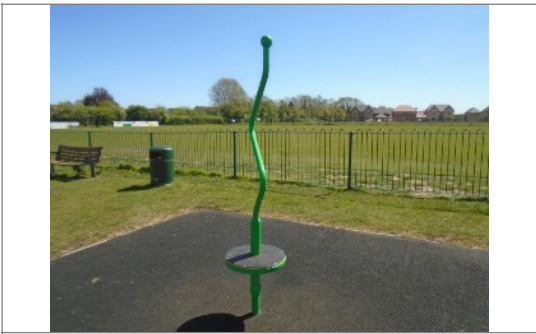
Wet pour sinkage evident. <b>Recommendation:</b> Monitor to repair this condition.	7
---	--	---

Slightly worn bearing evident. <b>Recommendation:</b> Monitor to replace bearing.	6
--	---	---

Wet pour edge shrinkage evident. <b>Recommendation:</b> Repair asap.	8
---	--	---

As above finding. <b>Recommendation:</b> As above comment.	8
---	--	---

<b>Item</b>	Twister				
<b>Supplier</b>	Wicksteed				
<b>Surface</b>	Wet Pour				
<b>Risk Rating Overall</b>	Very Low	Low	Medium	High	Unacceptable
			8

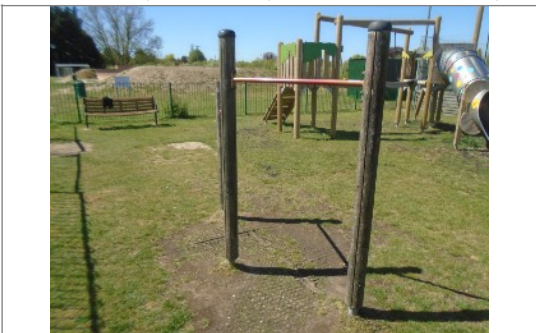
Post cap missing. <b>Recommendation:</b> Replace missing cap.	3
---	---	---

Decay/rot evident in places. <b>Recommendation:</b> Monitor this condition.	7
---	---	---

Gaps in matting evident. <b>Recommendation:</b> Replace as necessary.	7
---	---	---

<b>Item</b>	Chin Up Bars (Limited life)				
<b>Supplier</b>	HAGS				
<b>Surface</b>	Grass Matting				
<b>Risk Rating Overall</b>	Very Low	Low	Medium	High	Unacceptable
		7
